Collyweston Stone Slate

A Guide

Collyweston Stone Slate - Introduction

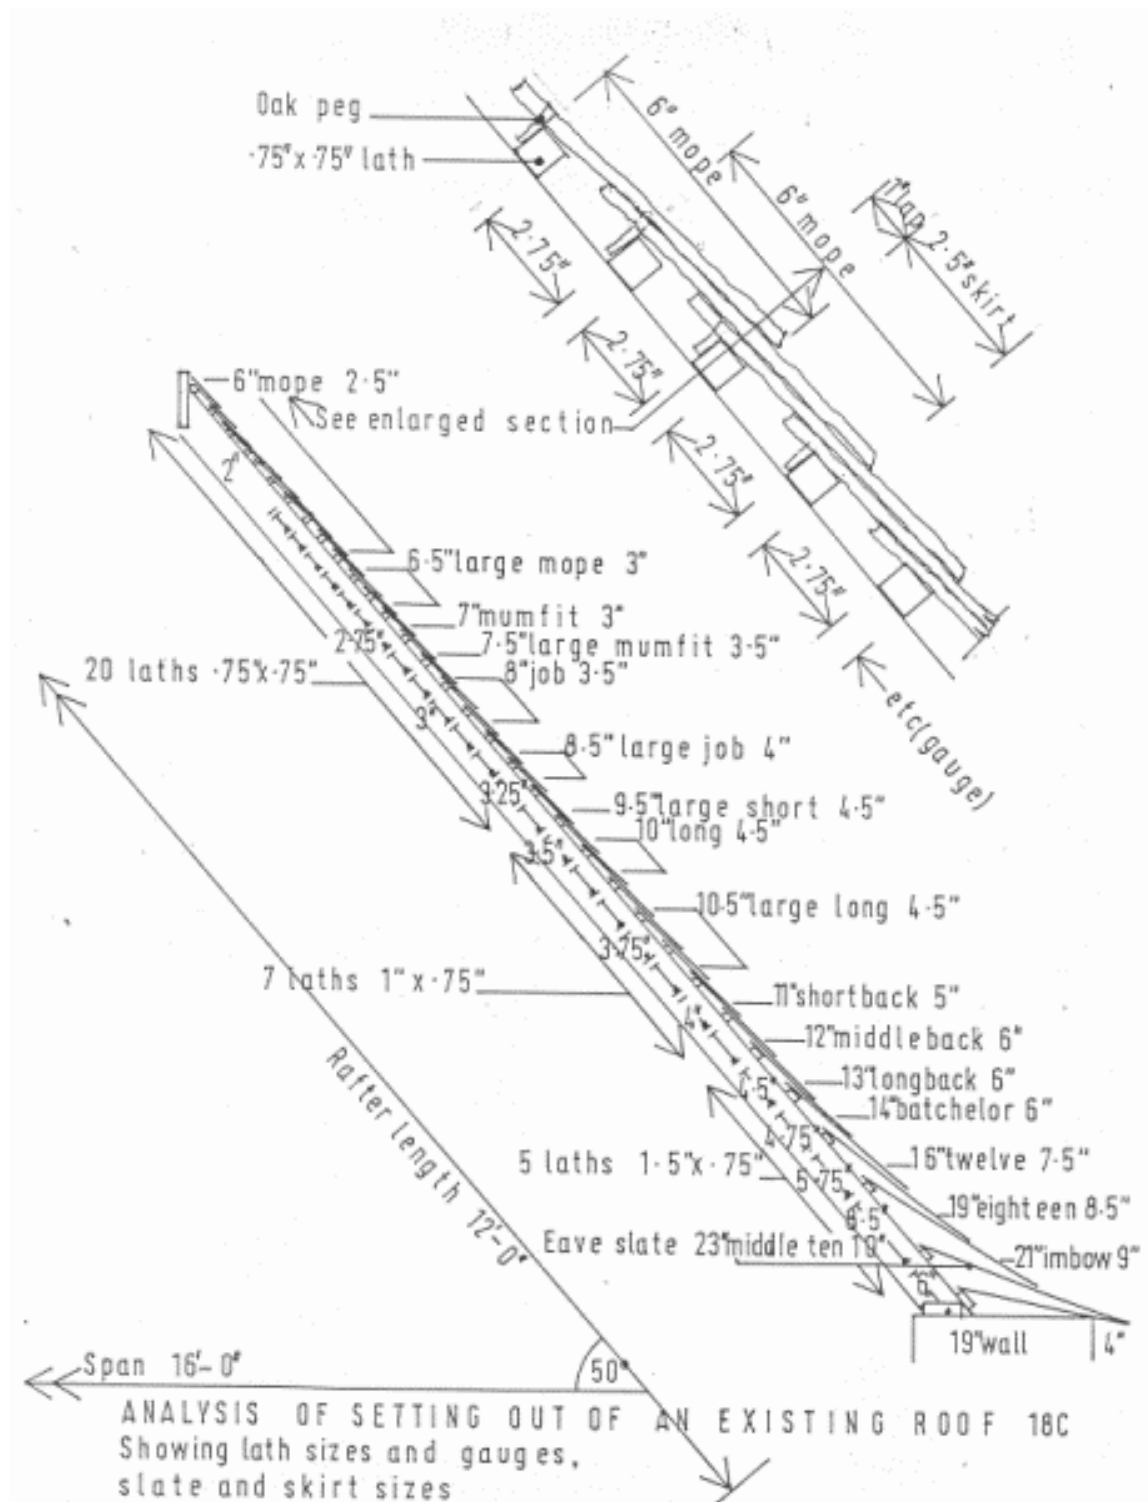
Setting Out A Collyweston Stone Slate Roof

Showing lath sizes and gauges, slate and skirt sizes

- ❁ Collyweston stone slates are always laid in diminishing courses from eaves to the ridge. The width of slates is random, but every half inch increase in length gives a slate its own special name.
